PERFORMANCE AND LONG DURATION TEST OF A 30 KW THERMAL
ARCJET ENGINE (U) JET PROPULSION LAB PASADENA CA
T J PIVIROTTO ET AL. NOV 87 JPL-D-4643 AFAL-TR-87-010

Performance and Long Duration Test of a 30 kw Thermal Arcjet Engine

November 1987

Jet Propulsion Laboratory

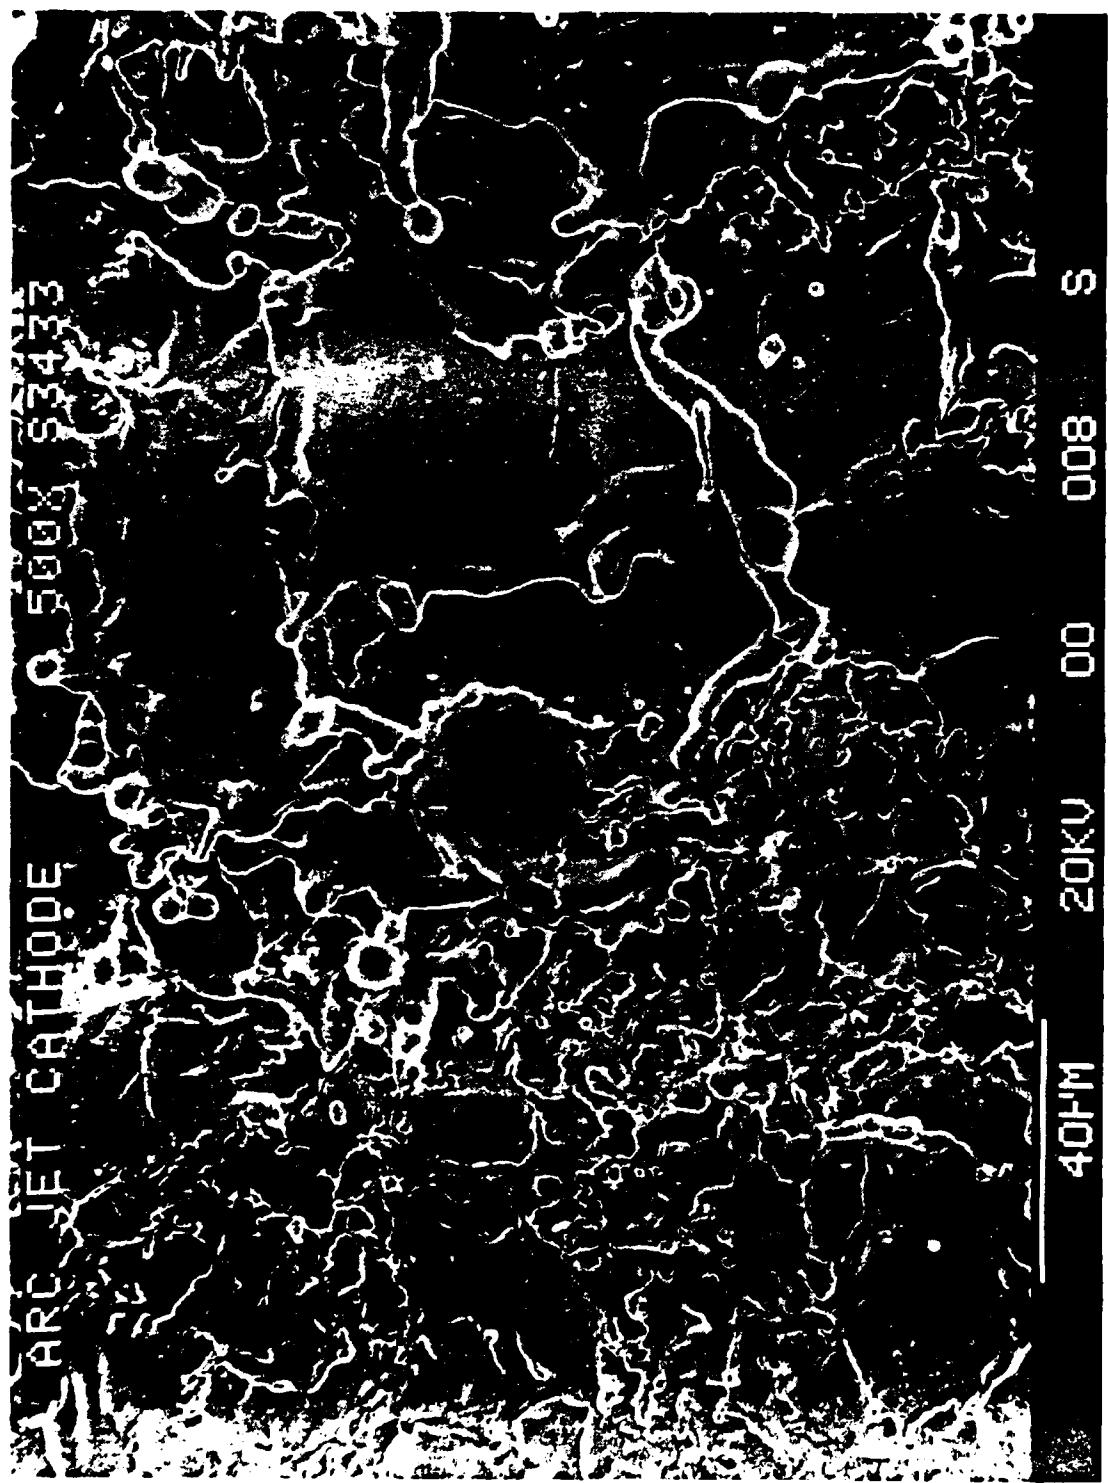
Figure 50. SEM Close-up of Cathode Crater Surface Completely Covered with Arc Microspots and Splashed Tungsten

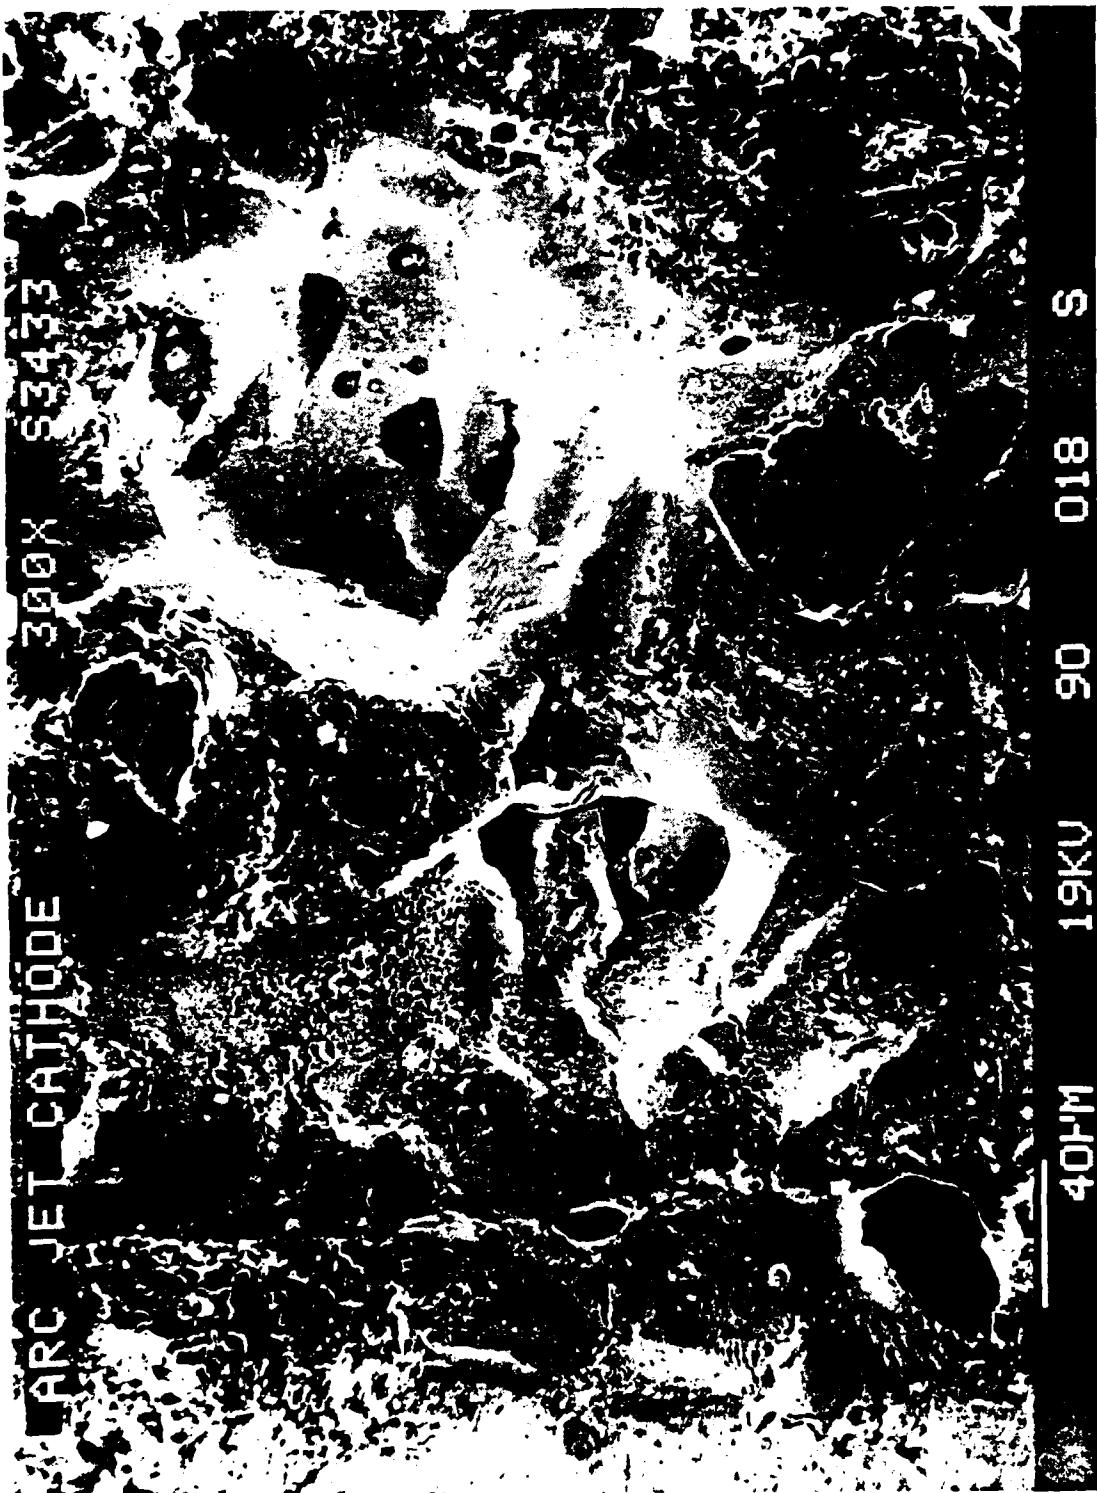
While most of the central crater surface was covered with arc micro-spots, indicating intense thermionic electron emission from this surface, the cathode outer cylindrical surface had none. Instead, this surface was found to be covered with approximately 50 μm diameter pits and with crystal facets, as can be seen in Figs. 51 and 52. The thermionic electron emission current density from this surface was probably much lower than that of the crater but there may have been substantial field emission from the sharp crystal edges. Where this surface was covered with the boron nitride insulator, see Fig. 9, the surface was smooth, unpitted and still showed machining marks. The cathode tip cone surface also was covered with pits and crystal facets but no micro-spots.

Figure 52. SEM Close-up of Pits and Crystal Facets on Cathode
Cylindrical Surface

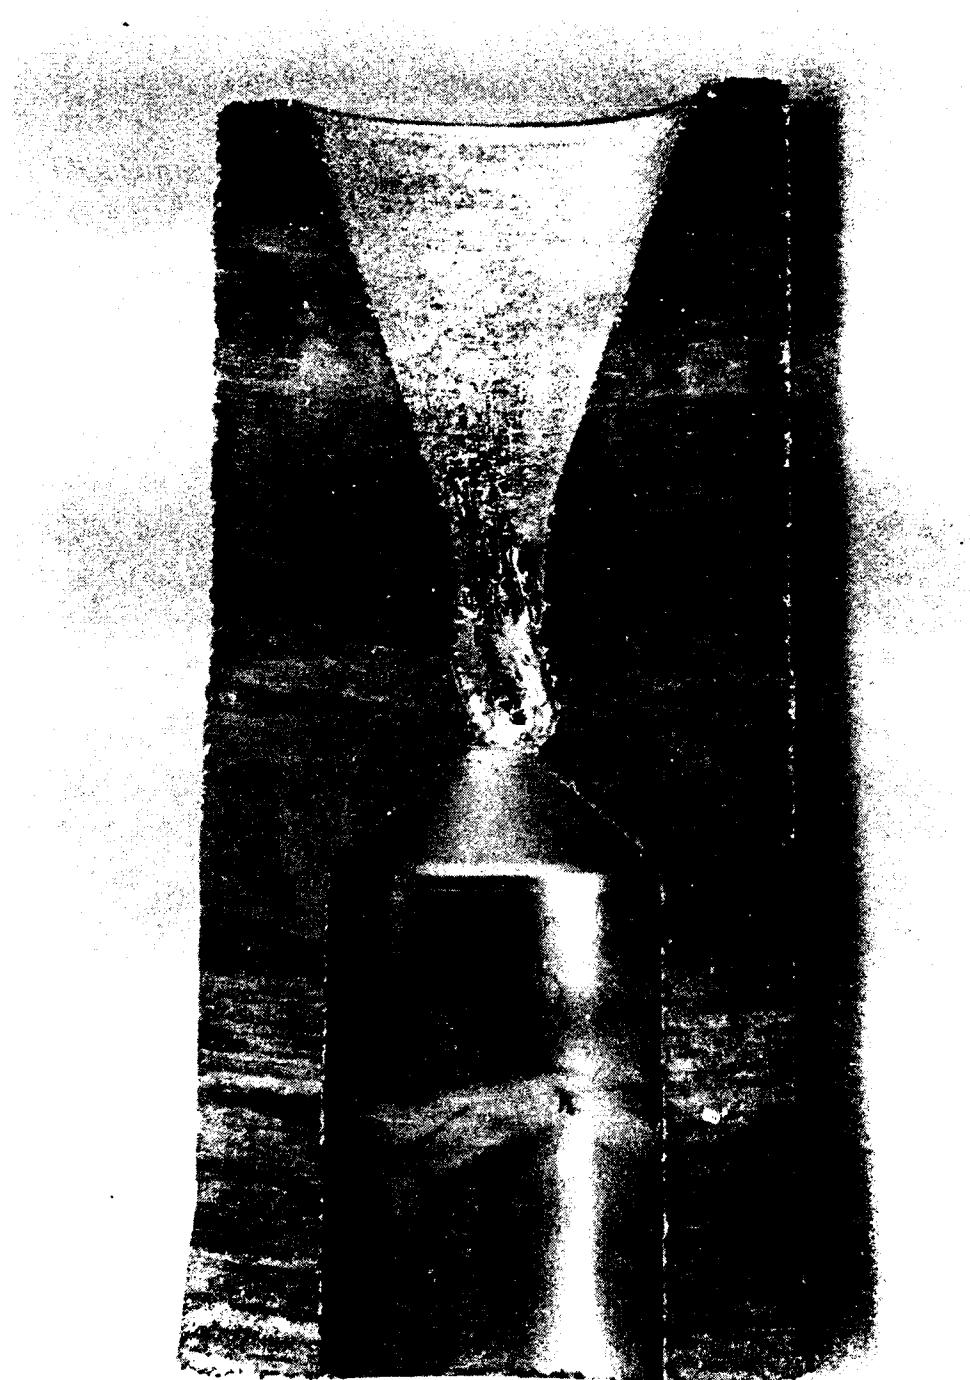
By weighing the nozzle before and after the long duration test, and subsequent damage, a net loss of 2.4 g was found. This loss must have occurred, primarily, when the constrictor was damaged during the attempted restart. This damage can be seen as a pit in the constrictor wall in Fig. 39 and more clearly in the picture of the other half of the nozzle shown in Fig. 53. Note, in Fig. 39, that the pit appears to start on a crack in the tungsten wall. That pit may have occurred early in the restart, when the nozzle was still relatively cold. Note also that the plenum chamber walls, though stained, were not affected by the long test duration. The machining marks are still visible on the 50° half angle cone wall.

Figure 53. Sectional Anode Block After 573 Hours of Accumulated Run Time. This is the Most Damaged Half

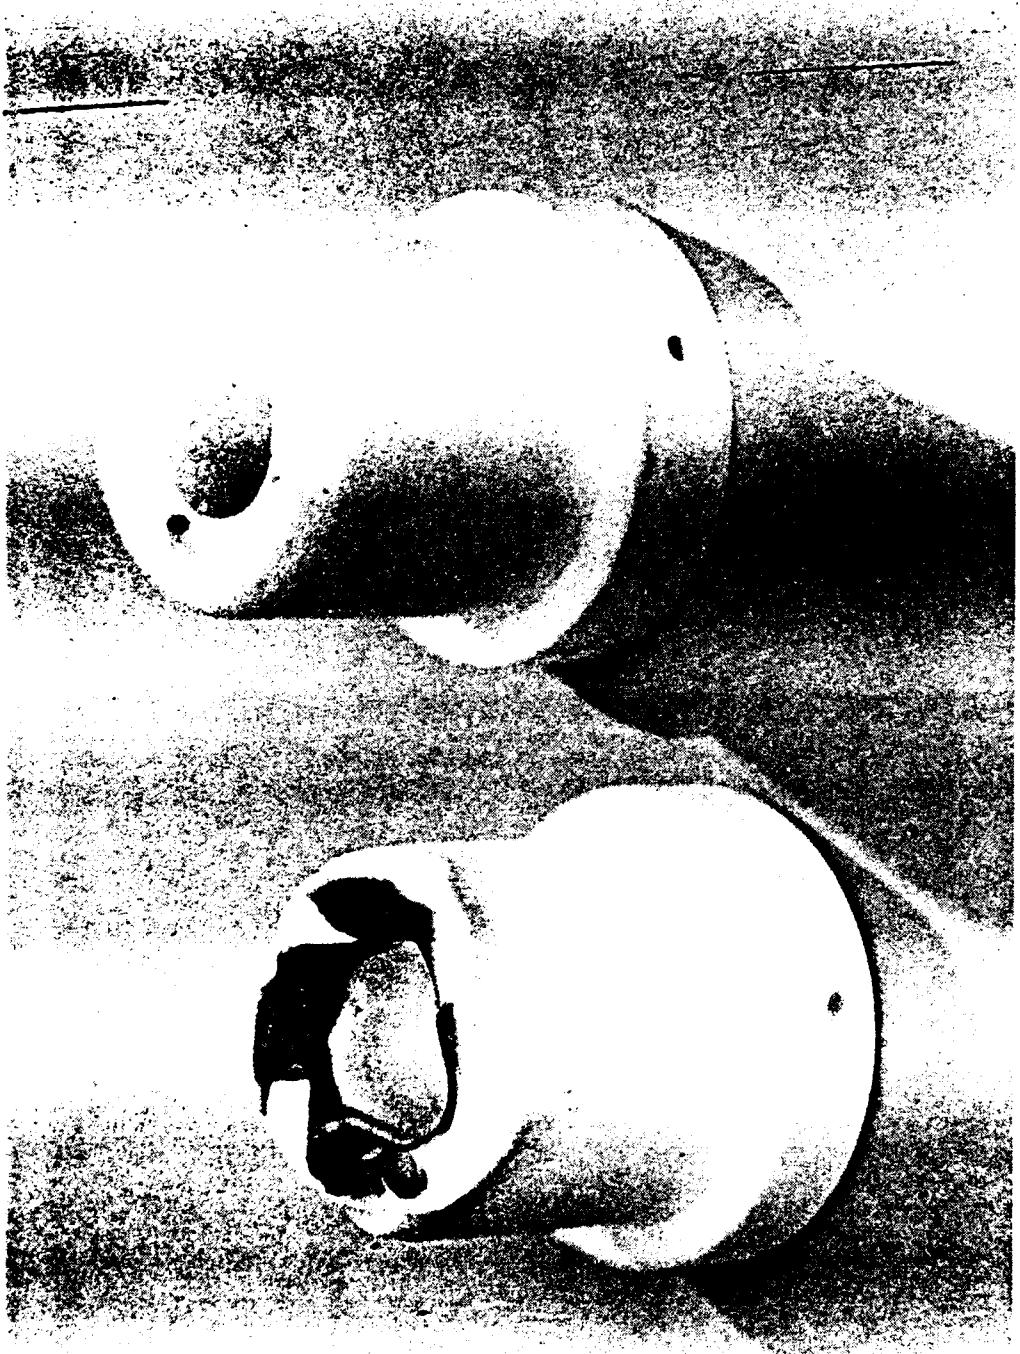
The eroded end of this propellant injector has been analyzed with an x-ray beam having a 600 μ spot size, and with a scanning electron microscope. The spots analyzed with the x-ray beam were composed of the black deposits that can be seen in Fig. 54 plus the boron nitride just below the deposit. The results of this analysis are given in Table 5.

Figure 54: Propellant Injector Before and After 573 Hours of
Accumulated Run Time
